June 21, 2015  
Project No. H-5072-15

**Subject: Limited Phase II Environmental Site Assessment Report  
Commercial Property Located at  
1057 W Manchester Ave, Los Angeles, California 90044**

**Limited Phase II Environmental Site Assessment Report  
Commercial Property Located at  
1057 W Manchester Ave, Los Angeles, California 90044**

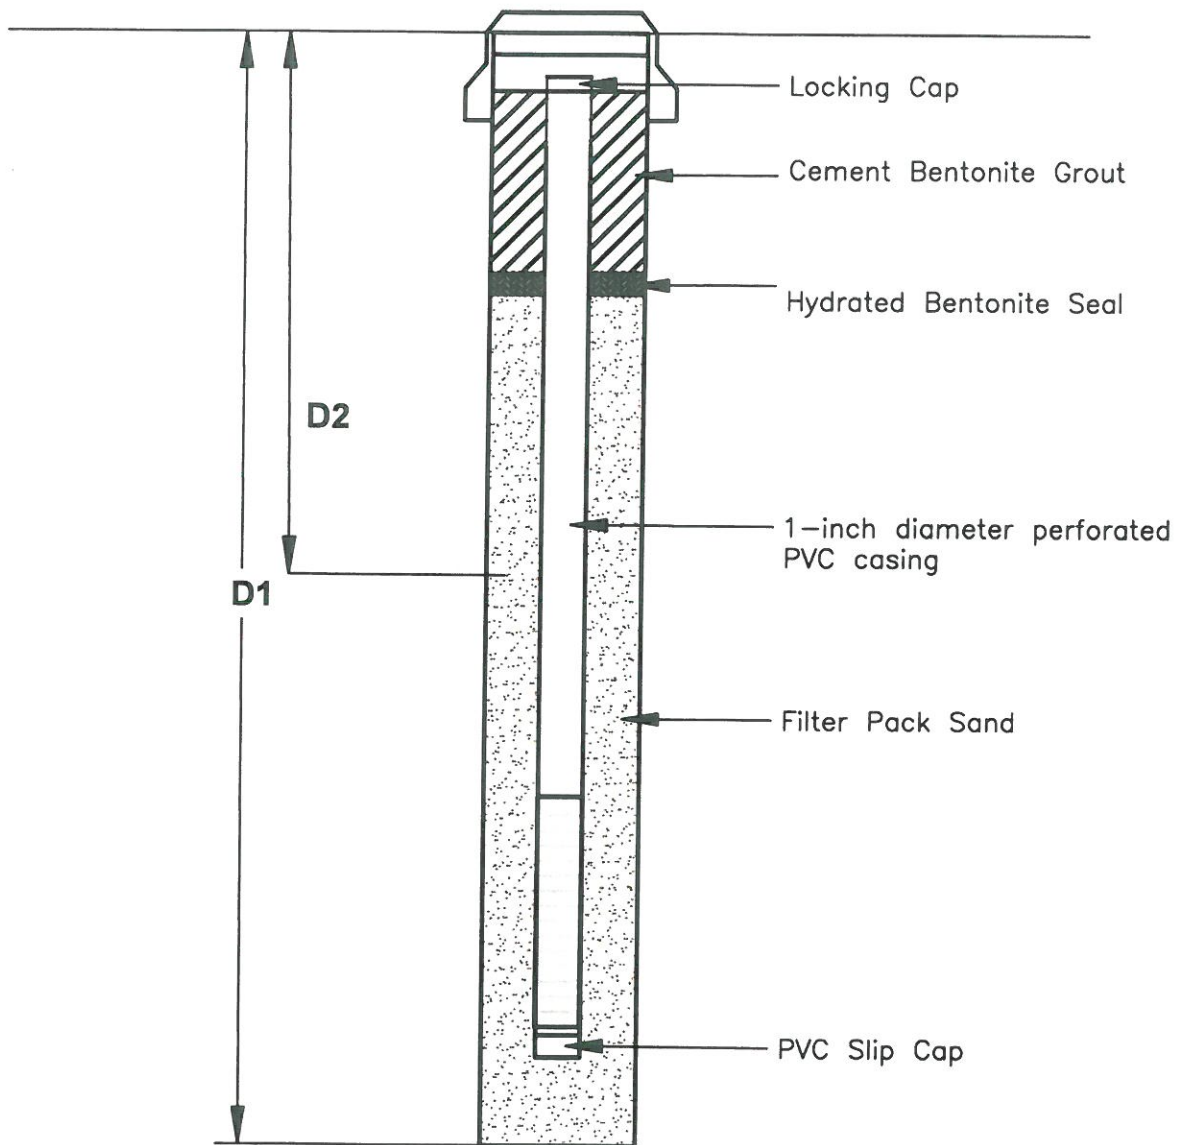
**SOIL PROBE AT 16 FEET**  
 FIGURE - 4  
 DATE : 6/ 18/ 2015 | SHEET 1 OF 1

5-foot Deep Soil Probe Details	
Total Depth (D1)	5 feet
Well Screen Slot Size (D2)	1 foot

Two boring advanced to a minimum of 16 feet below ground with soil sampling for geotechnical engineering purposes. The boring shafts then converted to deep soil gas survey. In addition three more boring were advanced to -5 feet below ground surface and then converted to soil gas probes.

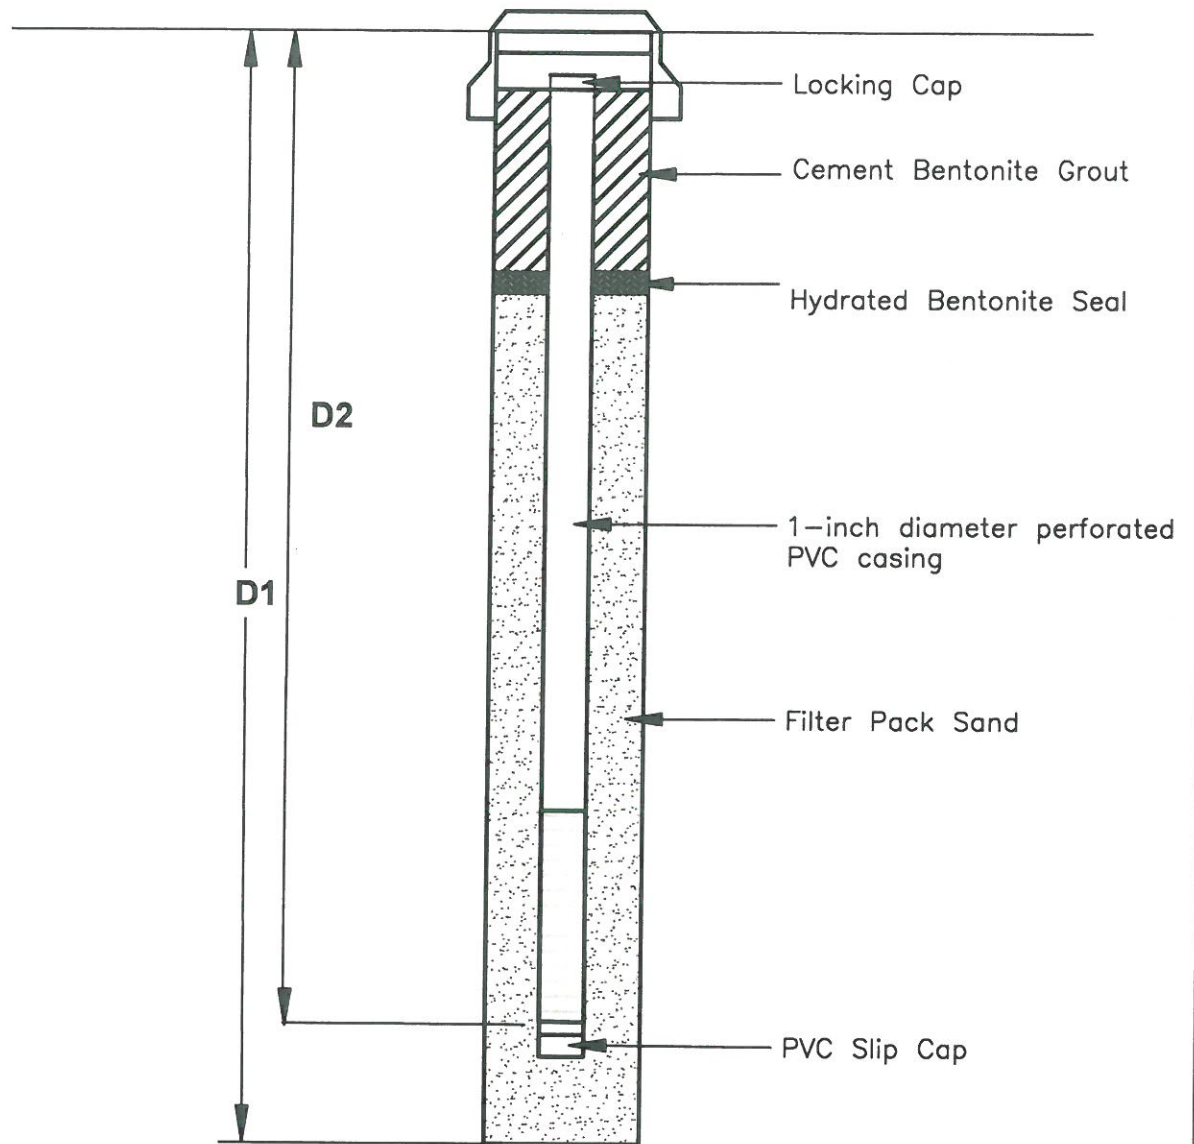
**SOIL PROBE AT 16 FEET**  
 FIGURE - 5  
 DATE : 6/ 18/ 2015 | SHEET 1 OF 1

16-foot Deep Soil Probe Details	
Total Depth (D1)	16 feet
Well Screen Slot Size (D2)	3 feet
