August 8, 2014
SS-202-S

Subject: SOILS ENGINEERING REPORT
Proposed Classroom Building & Lobby Addition, Faith Community Church, 355 D Street, Fillmore, California

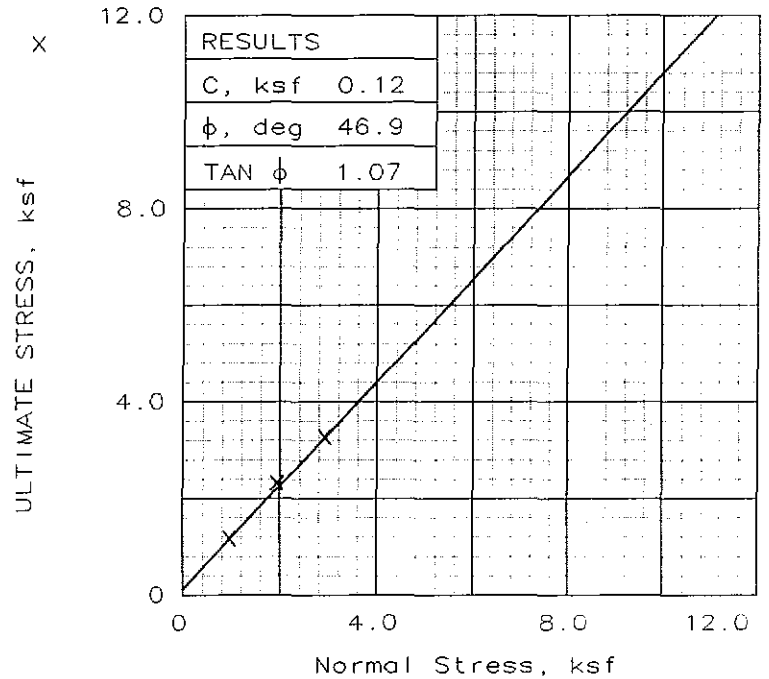
NORMAL STRESS, ksf	1.03	2.00	2.99
FAILURE STRESS, ksf	1.57	3.01	4.74
DISPLACEMENT, in	0.55	0.58	0.59
ULTIMATE STRESS, ksf	1.18	2.32	3.28
DISPLACEMENT, in	0.28	0.21	0.22
Strain rate, in/min	0.04710	0.04680	0.0464

SAMPLE TYPE: ALLUVIUM
DESCRIPTION: SAND
